**CANADIAN FORCES  
FLIGHT SAFETY INVESTIGATION REPORT**

**FINAL REPORT**

**FILE NUMBER:** 1010-C-GRGS  
**DATE OF REPORT:** 21 August 2002

**AIRCRAFT TYPE:** Cessna L-19 (C305)  
**DATE/TIME:** 17 June 2001 1842Z  
**LOCATION:** Campbell River British Columbia  
**CATEGORY:** B Category Air Accident

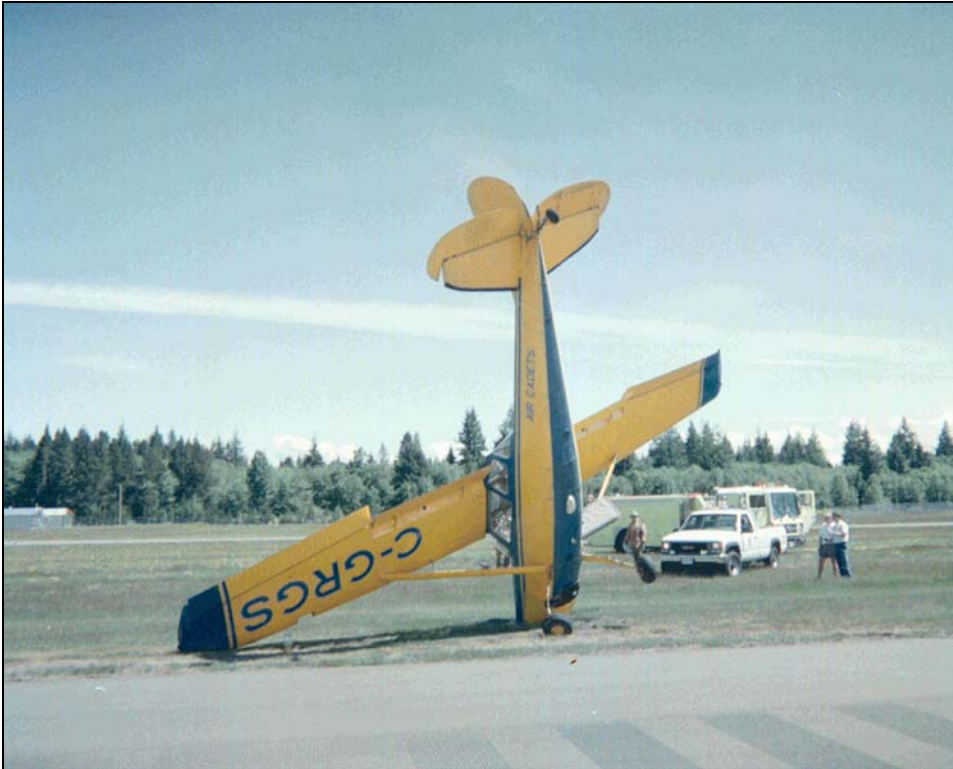
On the third landing on runway 29 at Campbell River, the aircraft experienced a “ground loop” and exited the paved surface on the right. The aircraft came to rest on its nose slightly off the pavement, 500 feet from the threshold (see photo 1). The crew exited the aircraft through the main door and were uninjured.

Evidence on the runway indicated that the aircraft bounced five times. The initial touchdown occurred on the runway centreline. At this point, the aircraft bounced and yawed slightly to the right in the quartering tailwind. The student did not adequately correct for the right yaw before the second touchdown and the aircraft bounced a second time and yawed further to the right. On the third contact with the runway, the aircraft was yawed sufficiently to the right to cause the left main landing gear to bend inward under the side load (see photo 2) and allow the left wheel hub to make contact with the pavement (see photo 3). By then, the instructor had taken control of the aircraft and although he was able to prevent the aircraft from yawing further to the right, he was not able to recover the aircraft before it exited the runway on the right and pitched forward (see photo 1).

**Photo 1 Final Resting Place**

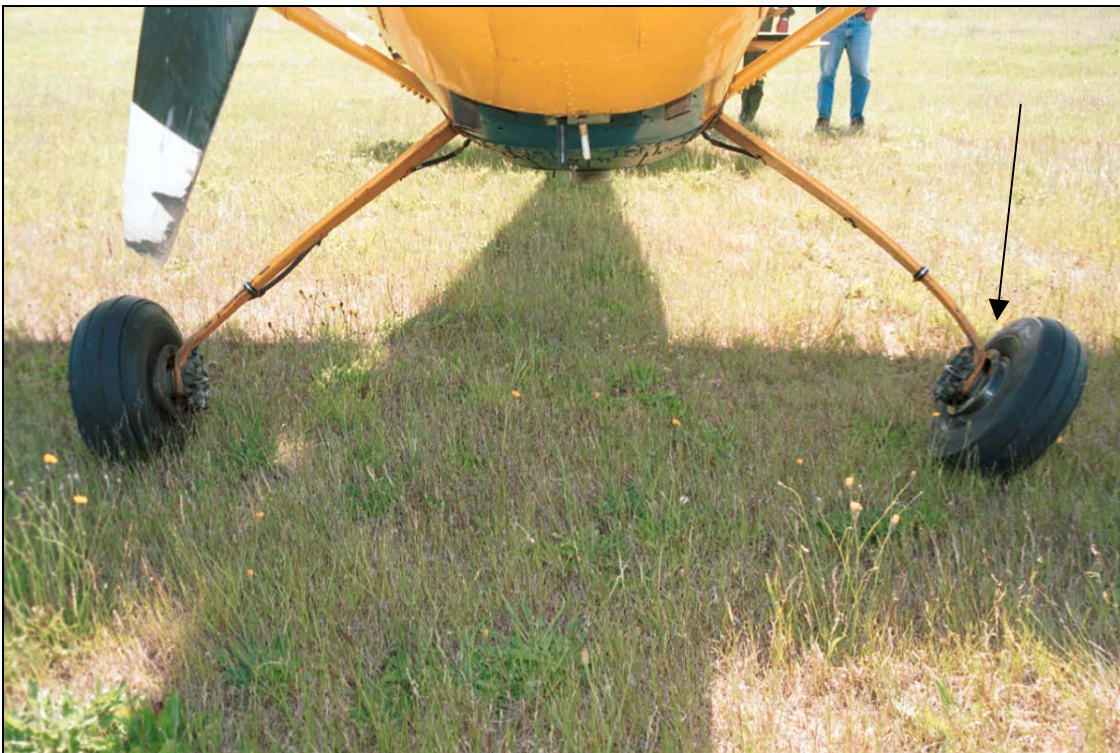
The aircraft received B Category damage. The left landing gear leg and wheel were damaged when the aircraft bounced up and landed sideways on the runway. The landing gear leg was bent inward allowing the wheel hub to make contact with the ground (see photos 2 and 3). There was also extensive structural damage to the landing gear attachment points inside the fuselage. The left wingtip and the nose areas were damaged when the aircraft came to rest on its nose (see photos 4 and 5). The aircraft has since been repaired by a local contractor and has been returned to service.

**Photo 2: Landing gear leg damage**

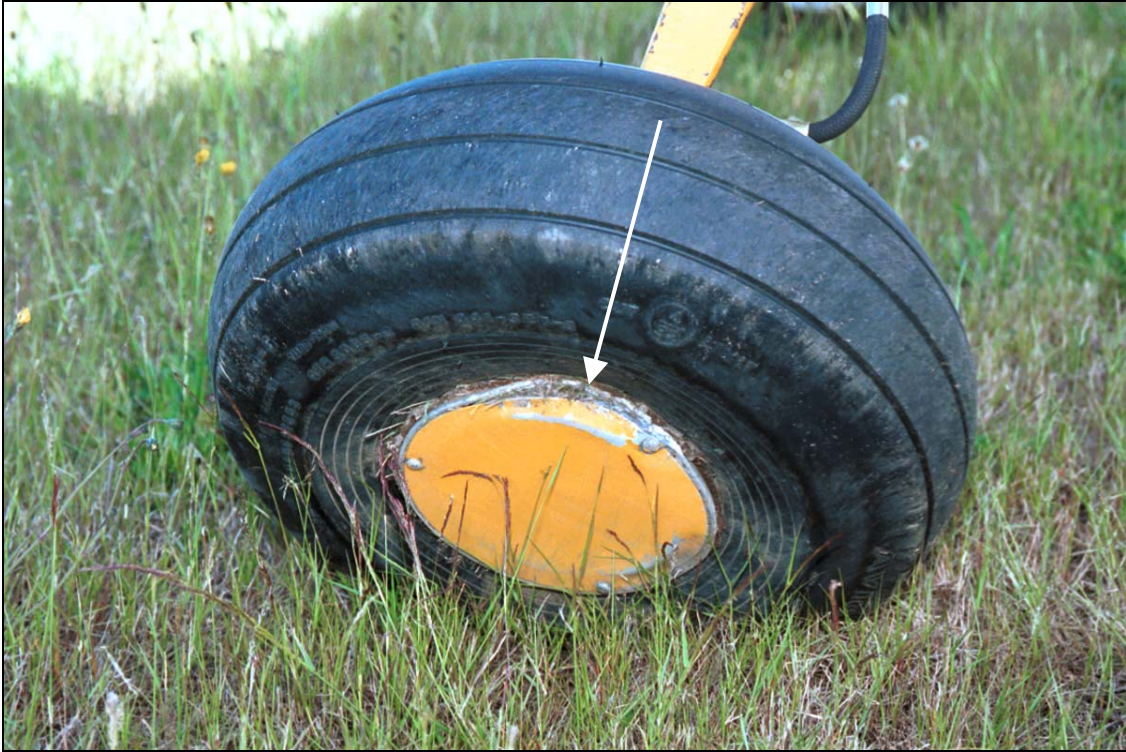
**Photo 3: Wheel damage**

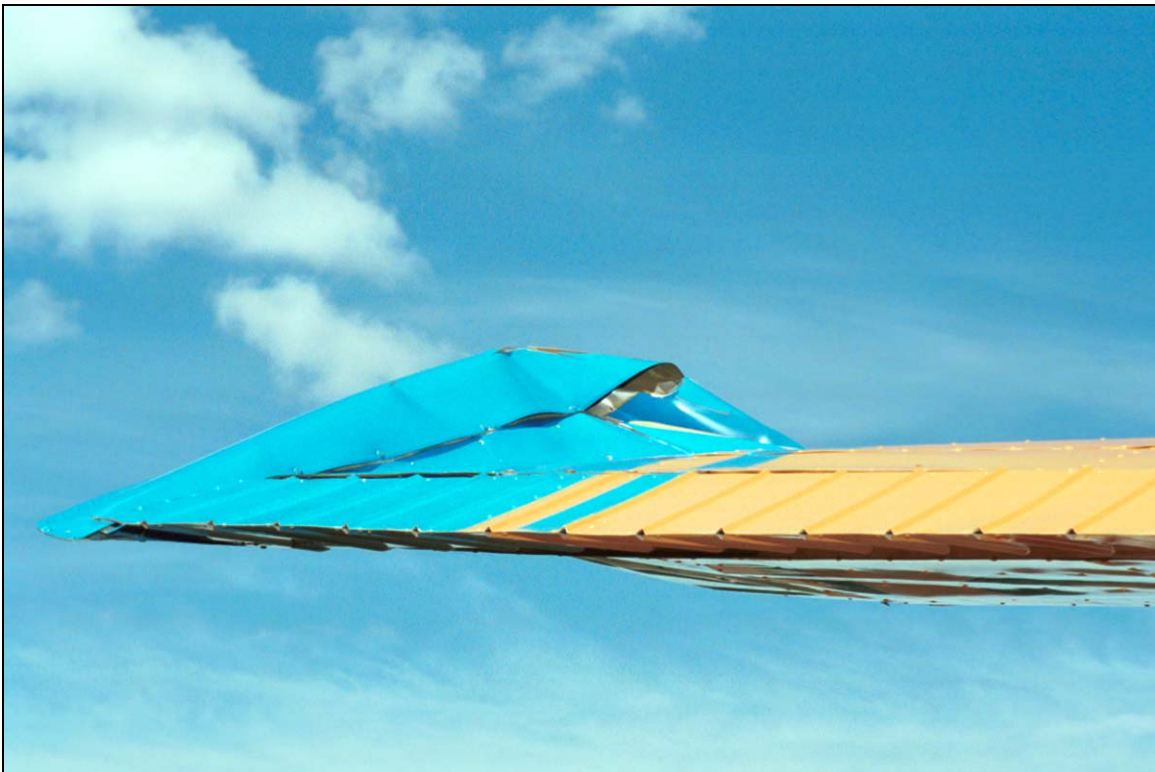
**Photo 4: Left wingtip damage**

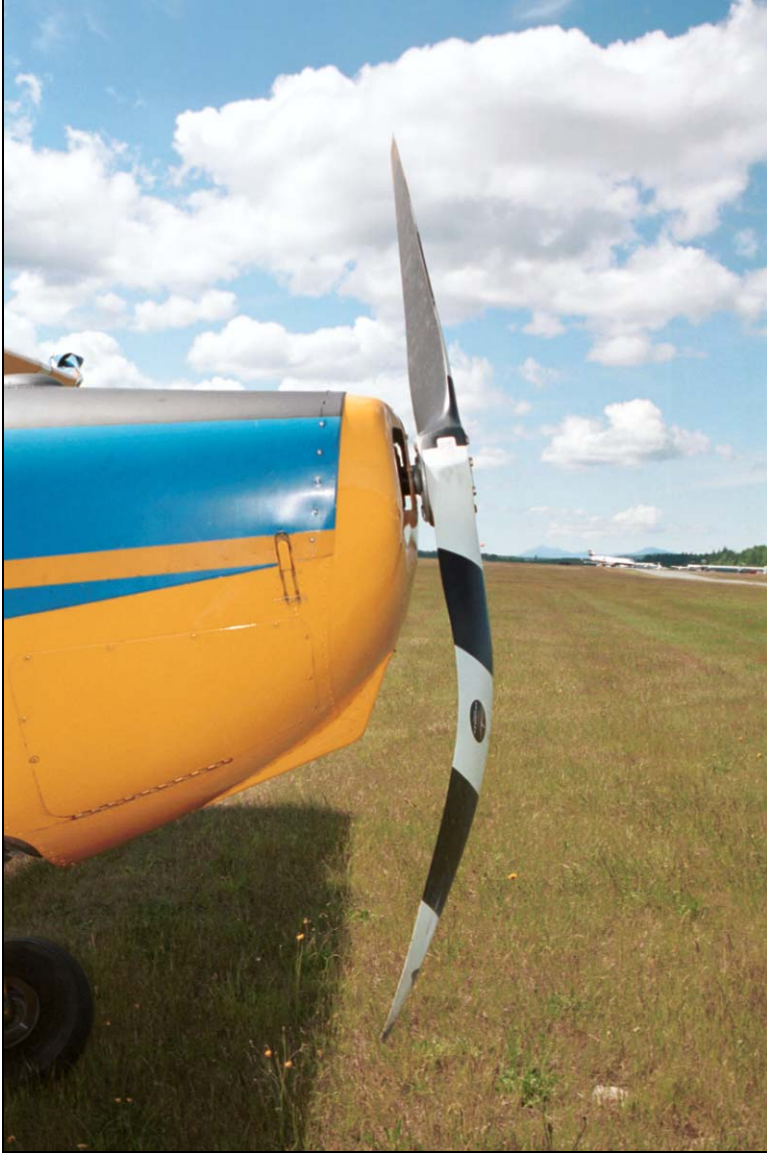
**Photo 5: Propeller damage**
